# *Investigation Report*

## *CenturyTel of Inter Island d/b/a CenturyLink*

*UT-132234*

*Staff Investigation  
Consumer Protection  
Regulatory Services*

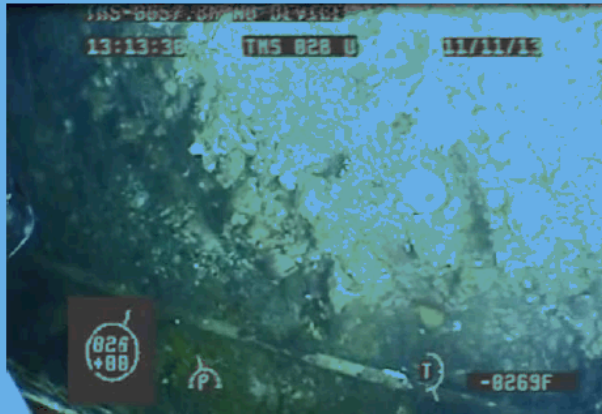
Figure 2 - Cable Wrapped on Rock Feature

Repair operations commenced on November 11, 2013 with a Remote Operated Vehicle (ROV) video inspection of the Century Link cable in the vicinity of the break. The ROV inspection revealed that the cable had been dragged north from its original position and pulled tight up against a rock feature.

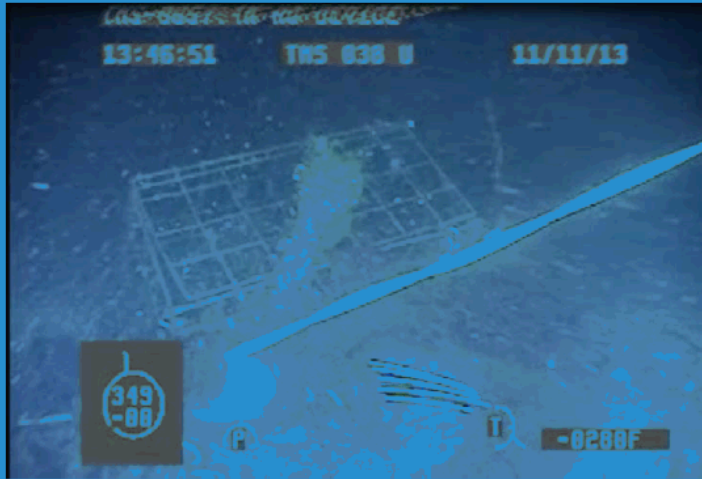
Figure 3 - Crab Pot with Polypropylene Line

A crab pot with polypropylene line was found entangled in the cable 90 feet west of the rock feature.

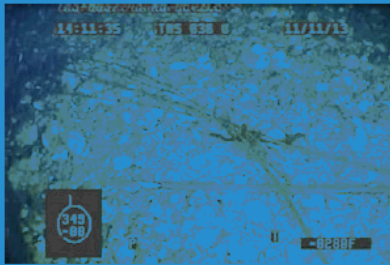
Figure 5 - Parted Cable End Eastern Side

The parted cable end on the eastern side of the break was found approximately 65 feet west of the entangled fishing gear and the end on the western side was found to be approximately 93 feet west of that.

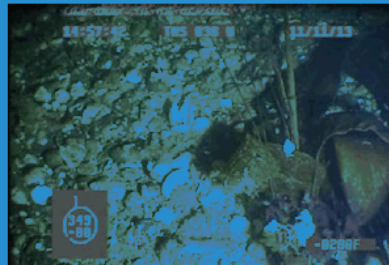
Figure 4 - Parted Cable End Western Side

As stated earlier, the cause of the break is still unknown, however, ROV inspection of the two parted cable ends strongly suggests that the cable fault was due to a tension break (as opposed to a localized failure due to abrasion).

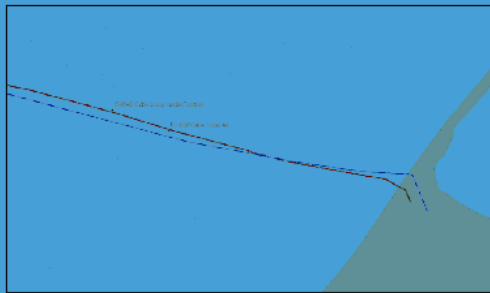
Figure 15 - Cable Loop Locations

The ROV also conducted video inspection of the Century Link cable starting west of the cable repair splice and then to the east, towards the Fishermen Bay landing. Areas of slight suspensions were found to the west of the cable repair splice.

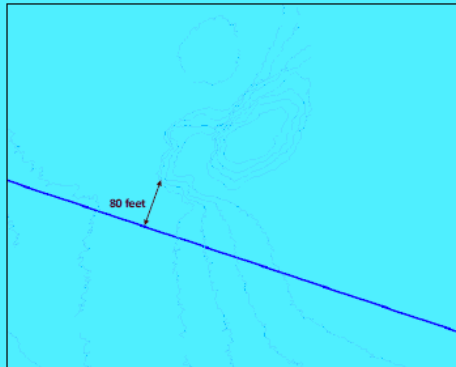
Figure 16 - Cable Route Separation from Rock Feature

Overlaying the 1999 cable route on the 2013 OPALCO survey data, the Century Link cable was installed within 80 feet of the rocky features within the cable corridor.

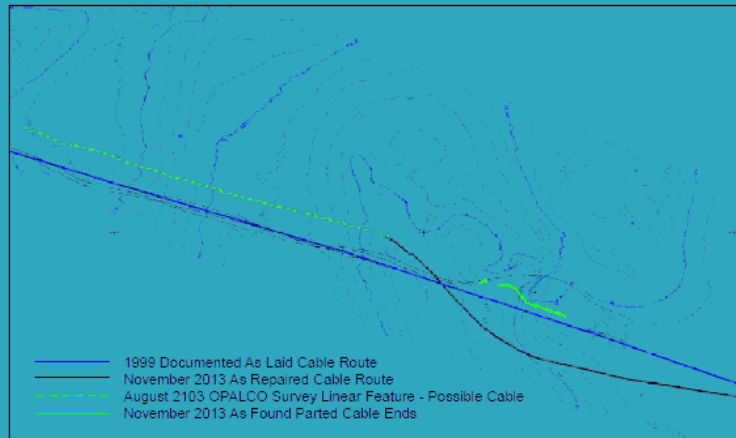
Figure 18 - Linear Feature Possible Actual As Laid Route

An observation worth noting is that the 2013 OPALCO route survey identified a linear feature that lines up with the Century Link repair splice position. The broken cable was found approximately 245 feet north of the documented 1999 as laid position. The linear feature (green dashed line in the drawing below) appears to run parallel to the 1999 cable route without any deviations or signs of localized displacement. It is possible that the cable laid in 1999 was actually laid 245 feet north of the documented route position list. This would have routed the 1999 Century Link cable through the rocky areas from the very start.

In hind sight, the cables in the San Juan Channel could have been buried below the seabed using either a towed plow or an ROV with jet burial capabilities. Cable burial should be considered for future cables crossing the channel.

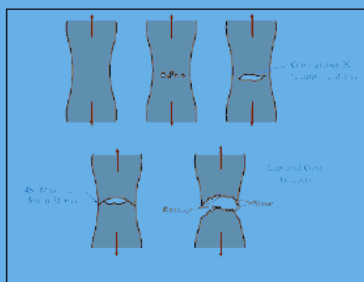
Figure 21 - Tension Break Characteristics

Visual inspection of the western parted cable end clearly indicated that the cable failed due to a tension break. Armor cable tension breaks are characterized by necking, or a thinning of the armor wires and copper sheath before failure.

It is of my expert opinion that the cable was dragged along the seabed by an anchor, fishing gear or some other towed device that caused the cable to wrap itself tightly around a large rock feature. The cable broke due to excessive tension over time after multiple entanglements or during a single entanglement event.

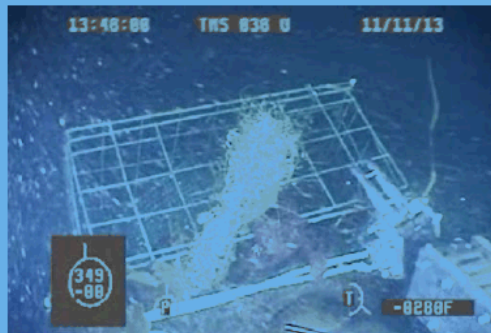
Figure 25 - Crab Pot Entangled with Cable

The ROV inspection shows one crab pot entangled in the cable and another, mostly buried, in a nearby area.

It is possible that a pot was involved in the cable fault, but it may also be a piece of derelict gear entangled in the cable before or after the break. Factors that make it a less likely cause include the fact that crab pots are legally required to be fished with one pot per buoy line. That means that strings of pots on "ground lines" that may be retrieved with grapnels are not used.

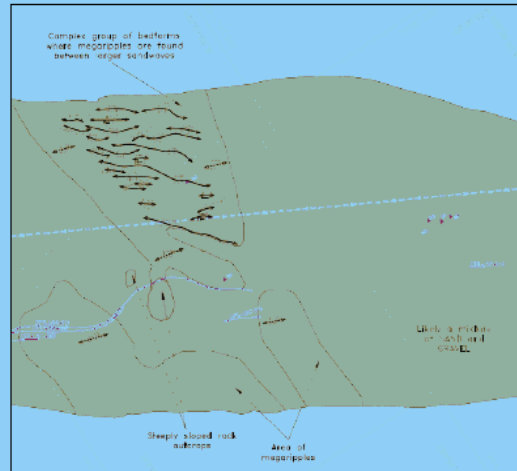
Figure 34 - 2013 OPALCO Survey Geophysical Interpretation

Post lay burial may be performed on sections of the Century Link cable in the middle of the channel. Geophysical data interpretations from the 2013 OPALCO survey indicate that most of the seabed along the cable is comprised of a mixture of sand and gravel.

An ROV with high pressure jetting swords could be used to retro bury the Century Link cable to a target depth of 1 meter below the seabed.

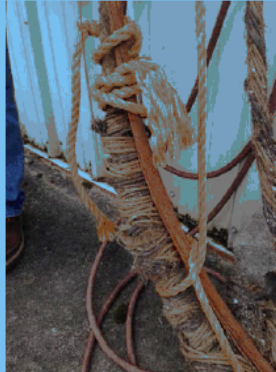
Figure 36 - Balled Up Jute

The 2013 OPALCO survey data indicates that several of cables in the vicinity of the cable break have been dragged to the north into the rocky areas. The 1995 OPALCO Power Cable repair encountered fishing nets entangled with the cable. The 2013 Century Link cable repair encountered a crab pot entangled with the cable and visual inspection of the cable showed damaged sections of jute indicating that the cable had been dragged along the seabed or that an object had been dragged along the cable.

This suggests that vessels have been active in the area and that the cables have been subjected to external aggression from bottom fishing, anchors or towed devices.
