Title: North Beach Road Tree Assessment
ISA Level 2 Basic Tree Risk Assessment
Eastsound, Washington

Prepared for: San Juan County Public Works
Attn: Jeff Sharp
PO Box 729
Friday Harbor, Washington

Date: February 16, 2021

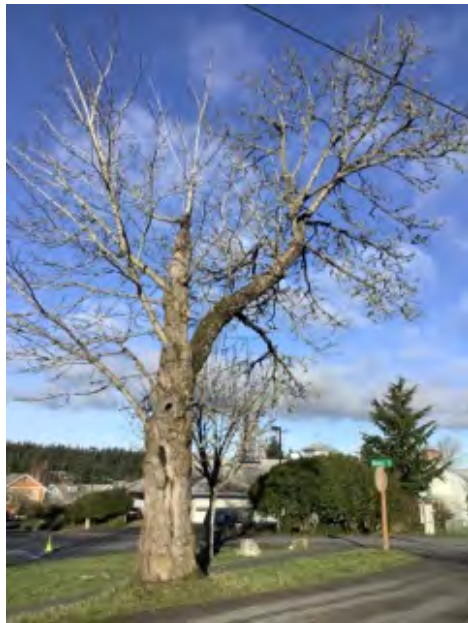
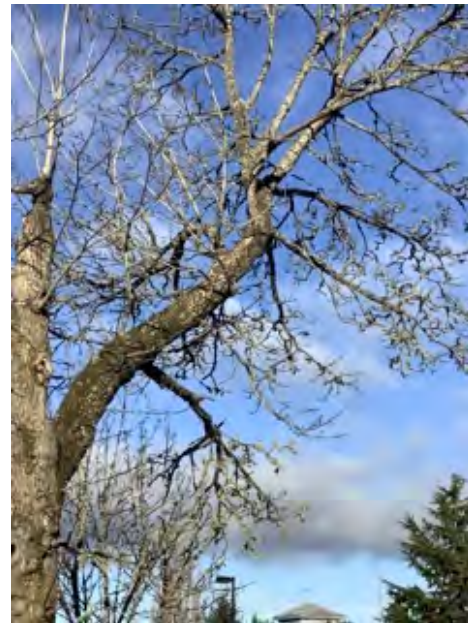
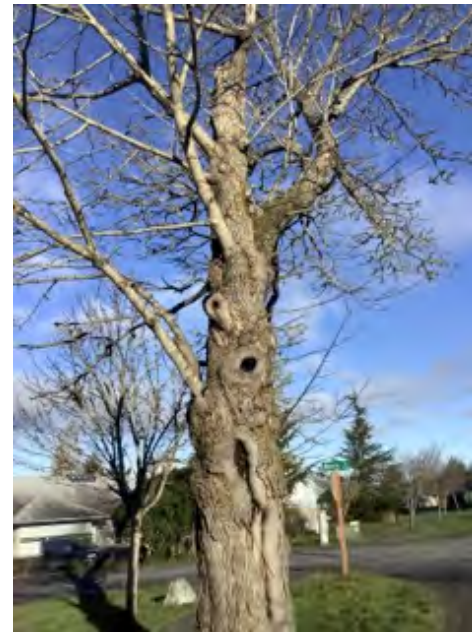
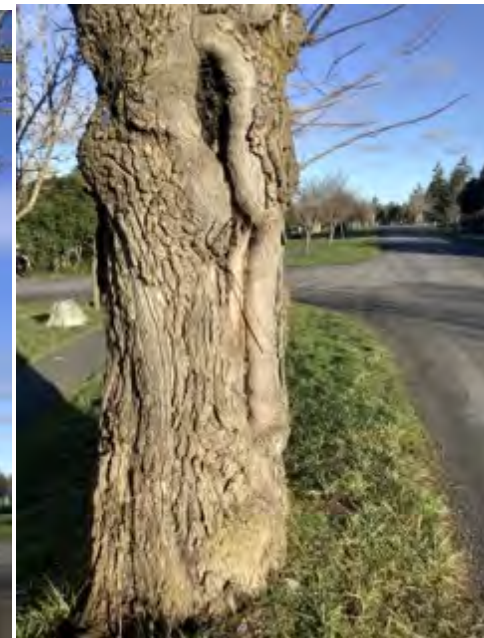
Failure of the main stem or a codominant stem is probable, the likelihood of falling onto the path is medium to high, and the consequences of failure are significant to severe for trees #1, #4, #7, and #9. They have at least a moderate risk rating. The other trees assessed for this report have a low risk rating although some have dead or weak branches over the path that are likely to fail. Approximate sizes of the dead branches range in diameter from 1 to 6 inches and as long as 12 feet. In general, the crowns are relatively low, and dead branch height ranges from approximately 12 to 35 feet above the path.

Tree	Species	DBH (in)	Drip Rad.	CRZ (ft)	Vigor	Structure	Risk	Pres Value	Recommendations
1	Maple <i>Acer species</i>	29.4	14.3	29.4	Fair to Good	Fair	Moderate		Remove dead branches over path Reduce length of 2nd stem
Notes/ Defects	<p>There is a cavity and exposed dead wood on the east side of the lower trunk. Kretzschmaria is present. The primary stem was topped at approximately 15 feet. The secondary stem has a solid union. There are larger dead branches over the path, including hangers. The crown should be cleaned of dead branches over 2 inches in diameter.</p>

- #1 – Within 6 months prune dead branches from the crown over the path and reduce the secondary stem growing towards the road by about 10 feet back to a suitable lateral branch for end weight reduction. Remove and replace the tree in 5 to 7 years.

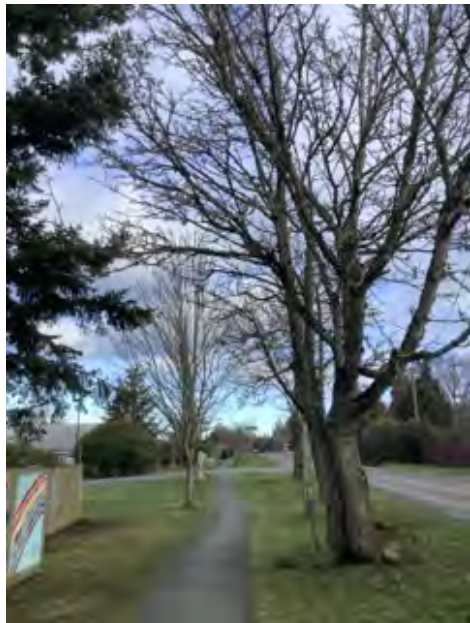
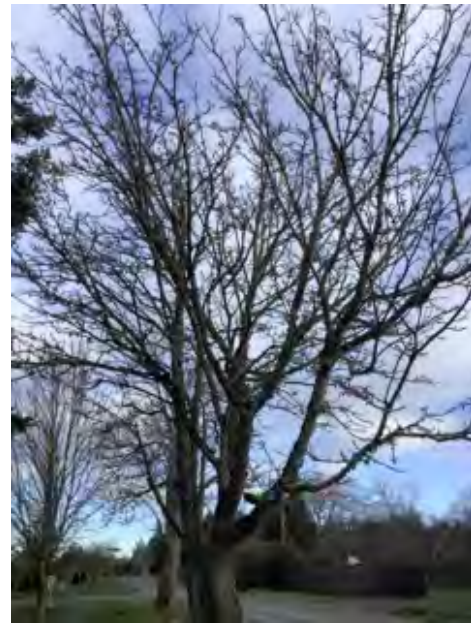
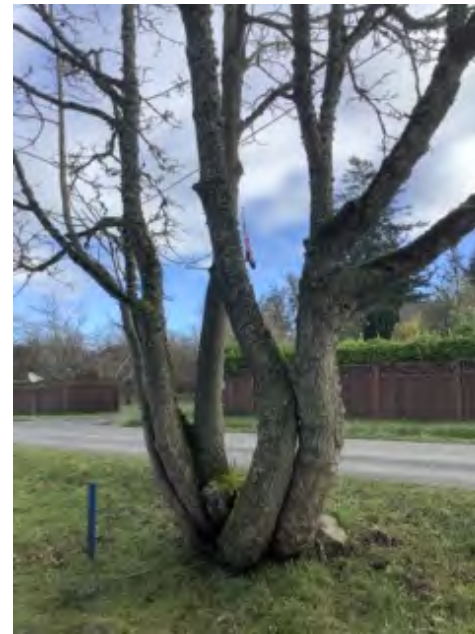
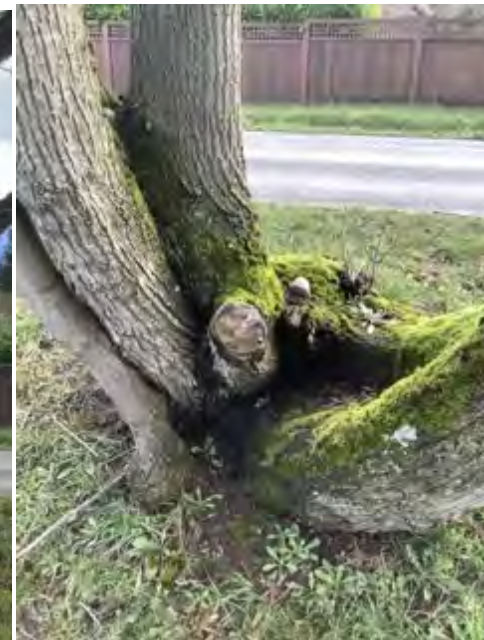
Tree	Species	DBH (in)	Drip Rad.	CRZ (ft)	Vigor	Structure	Risk	Pres Value	Recommendations
2	Maple <i>Acer species</i>	22.3	13.8	31.5	Fair to Good	Fair to Good	Low		Monitor for vigor and decay Maintain current height
Notes/ Defects	The codominant stems are mostly vertical and they have excellent taper. There may be some interior decay at the base of the tree at the site of old wounds from the removal of stems.

- #2 – The cavity at the base is compartmentalized and the tree is a low risk at its current height. Maintain the height with crown reduction pruning at 5 year intervals.

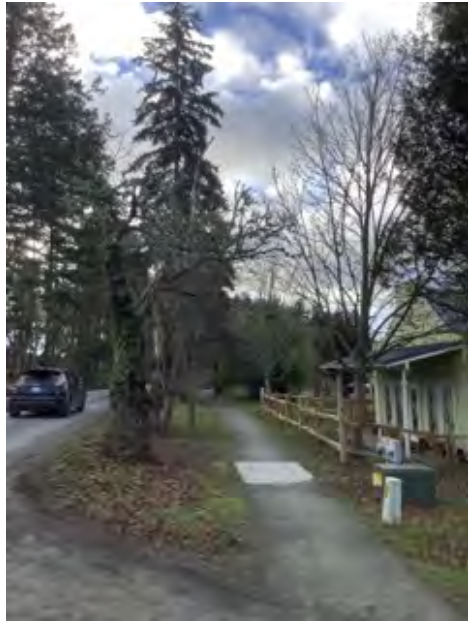
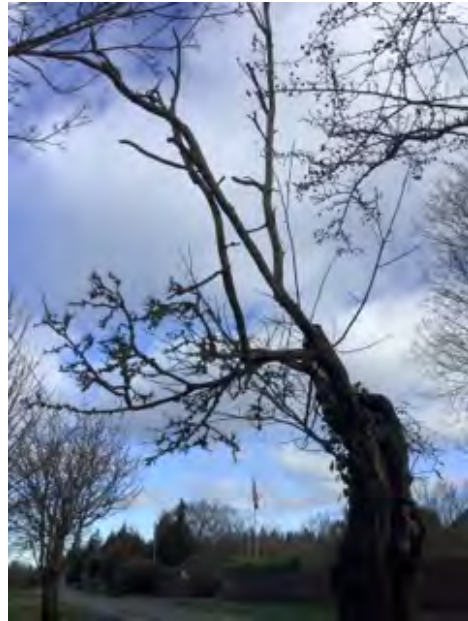
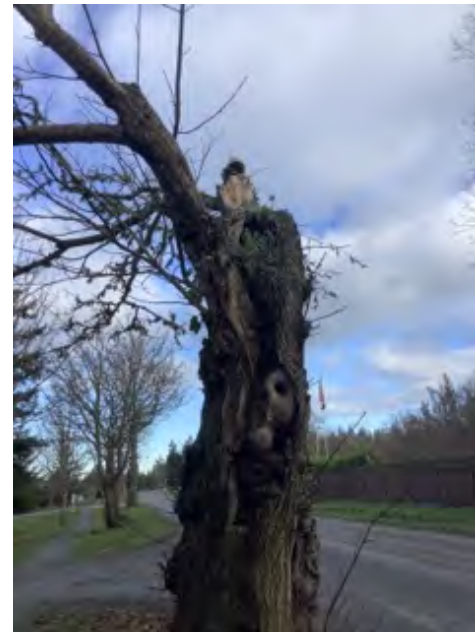
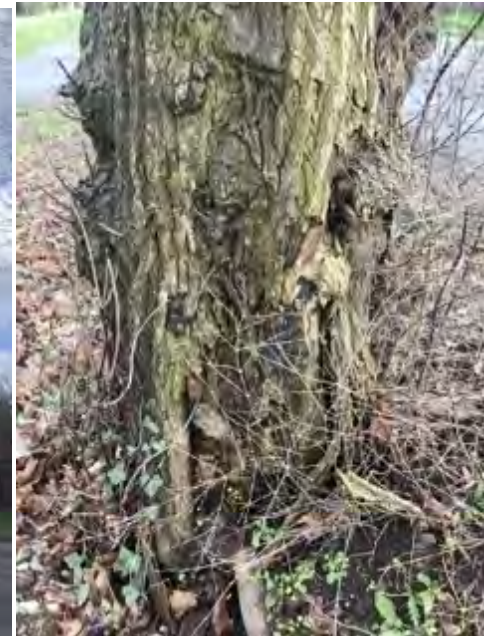
Tree	Species	DBH (in)	Drip Rad.	CRZ (ft)	Vigor	Structure	Risk	Pres Value	Recommendations
3	Maple <i>Acer species</i>	27.8	8.5	27.8	Poor	Poor	Low		Convert to wildlife snag Control English ivy
Notes/ Defects	<p>The main trunk is approximately 12 feet tall and there are a few small sprouts growing out the side. There are two dead branches over the path. The tree is in decline and it could be removed and replaced. It is a good candidate for a wildlife snag that could be accomplished by removing all the live branches and leaving the main trunk. English ivy is colonizing the tree and it should be controlled.</p>

- #3 – Convert to a wildlife snag by removing all branches within 12 months. Remove English ivy. Re-assess in 5 years. Plant a new tree to replace the canopy.

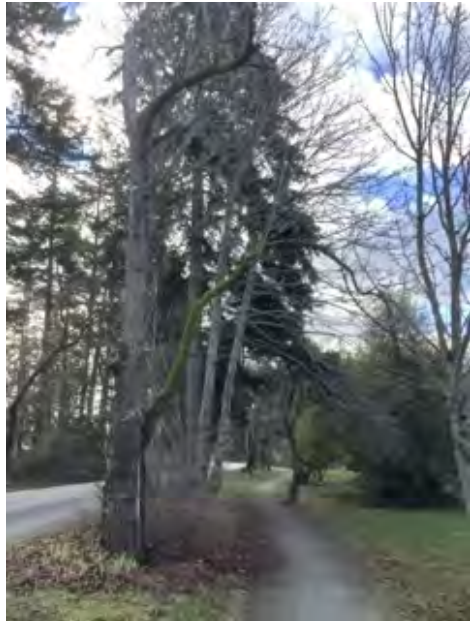
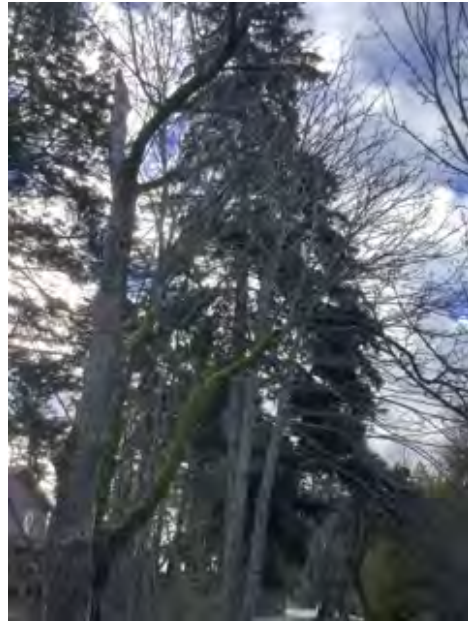
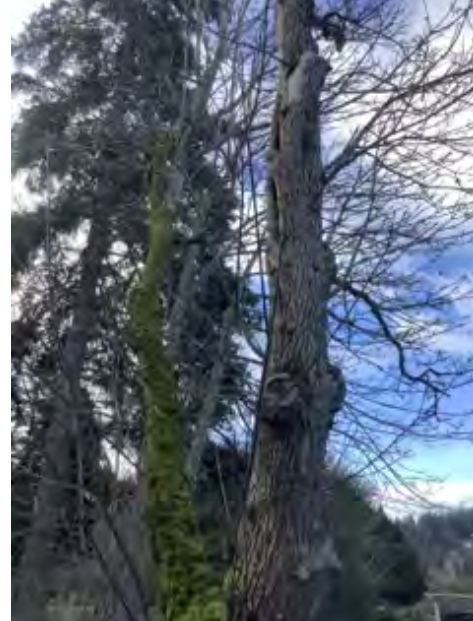
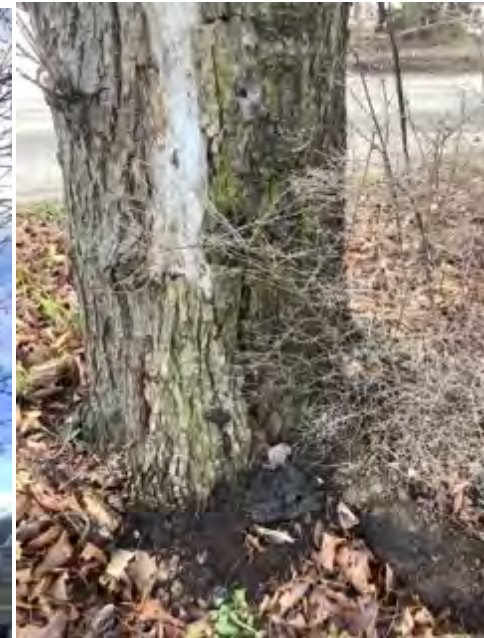
Tree	Species	DBH (in)	Drip Rad.	CRZ (ft)	Vigor	Structure	Risk	Pres Value	Recommendations
4	Maple <i>Acer species</i>	26.5	14.5	26.5	Poor to Fair	Poor	Moderate		Remove tree within 2 years Remove dead branches over path
Notes/ Defects	There is advanced decay and Kretzschmaria in the trunk on the sidewalk side of the tree. Two dead branches are over the path and should be pruned out. One large branch on the south side of the tree could be reduced back to the nearest vertical stem for end weight reduction.

- #4 – Remove the tree within 2 years and replace it with a new tree. The tree has a moderate risk rating that will continue to be more of an issue as the decay advances.

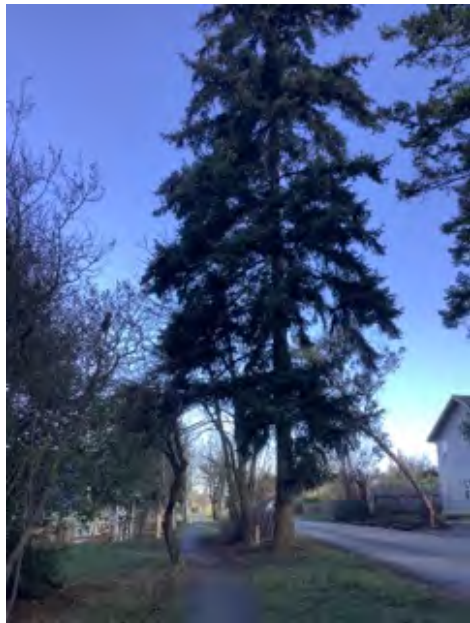
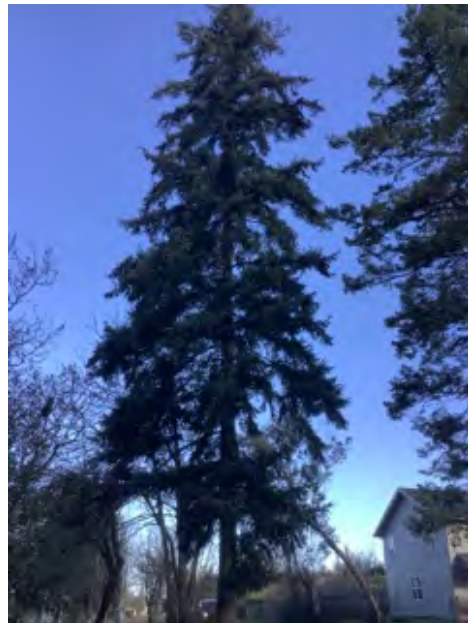
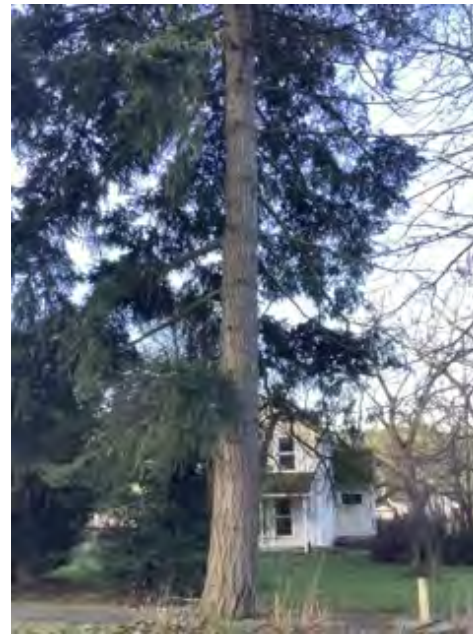
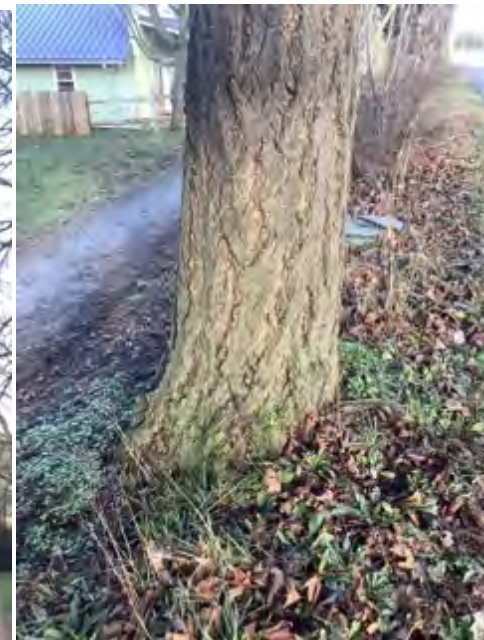
Tree #5, a Douglas fir, is healthy and its structure is resistant to wind throw. It was included in this assessment with the trees with more obvious issues because a nearby resident was concerned about wind firmness of the taller Douglas fir trees after clearing for new development across the street. Tree #5, as well as the small group of other Douglas fir trees next to the pathway, have good vigor and no visible structural defects or symptoms of disease that could significantly increase their risk rating. Branch failure of healthy branches is possible in high wind events or heavy snow loading, which is normal for the species.

Tree	Species	DBH (in)	Drip Rad.	CRZ (ft)	Vigor	Structure	Risk	Pres Value	Recommendations
5	Douglas fir <i>Pseudotsuga menziesii</i>	23.8	13.5	23.8	Good	Good	Low		Retain tree
Notes/ Defects	<p>This is a healthy tree with excellent taper and a 90 percent live crown to height ratio (LCR). The crown is slightly asymmetrical and weighted to the southwest. Branch failure during a high wind event is possible, but the damage would likely be minor. No action is required at this time.</p>

- #5 – Retain the tree as it is at a low risk rating.
- #6 – Remove the two stems growing over the path within 6 months. Remove and replace the tree within 5 years.

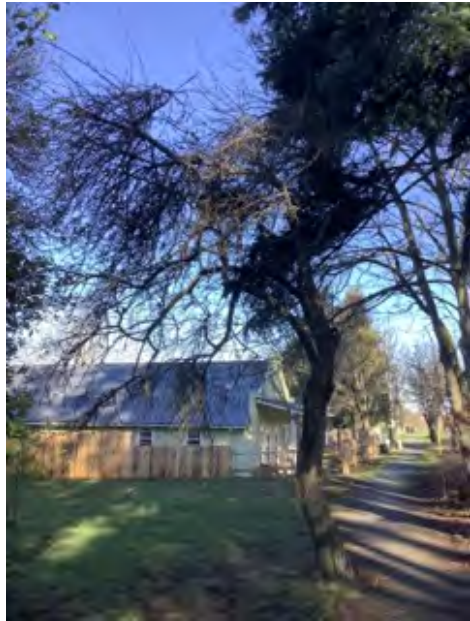
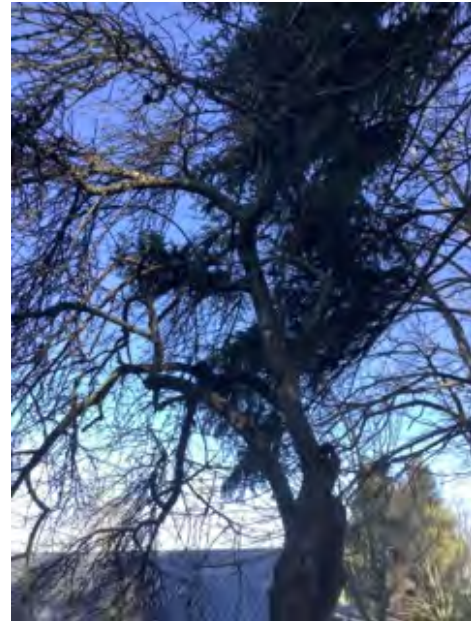
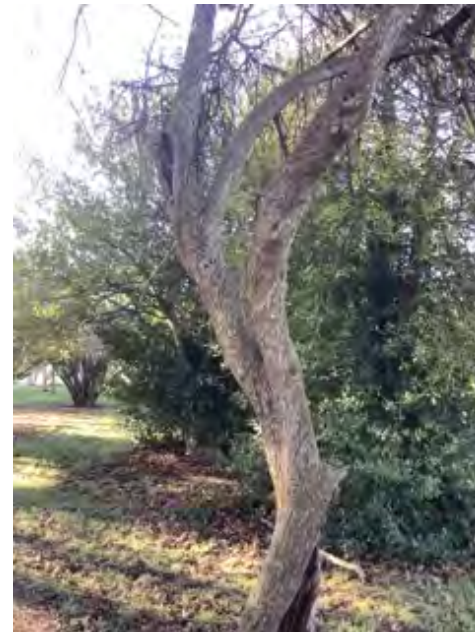
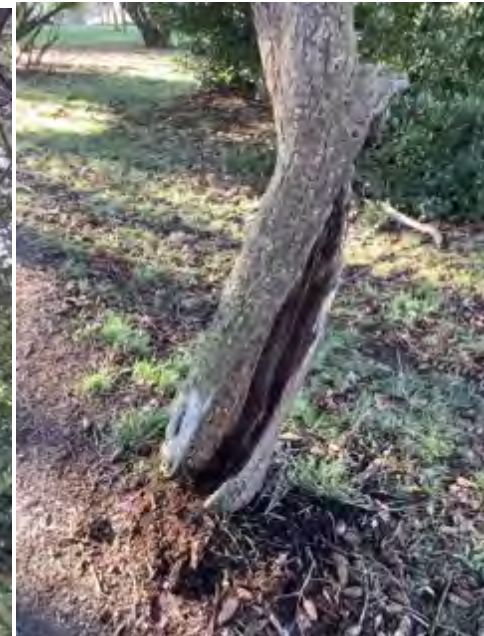
Tree	Species	DBH (in)	Drip Rad.	CRZ (ft)	Vigor	Structure	Risk	Pres Value	Recommendations
6	Apple <i>Malus domestica</i>	10.0	8.0	10.0	Dying/Dead	Dying/Dead	Low		Remove branches over path Remove within 2 years
Notes/ Defects	The crown is about 95 percent dead and there is a large cavity in the trunk. The tree is leaning and weighted away from the path on the private property side. There are no structures or high use areas under the tree if it were to fail in the direction of lean. Two stems over the path can be pruned out and the tree retained for wildlife.

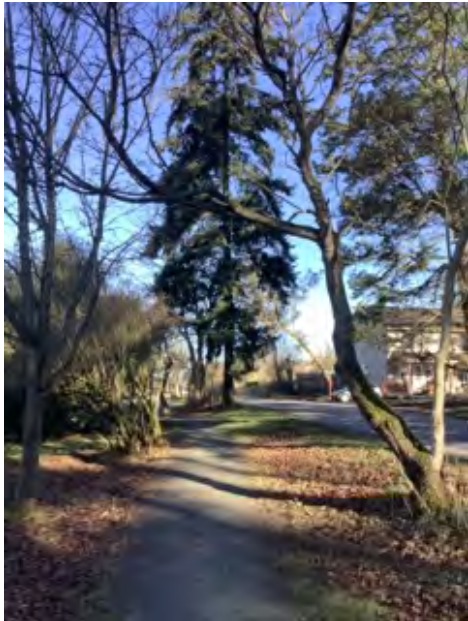
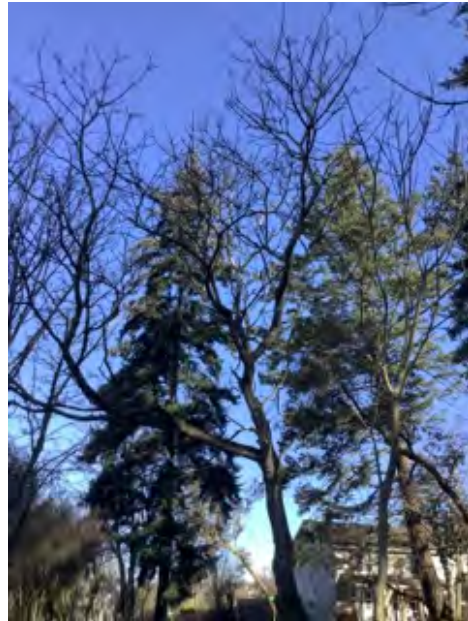
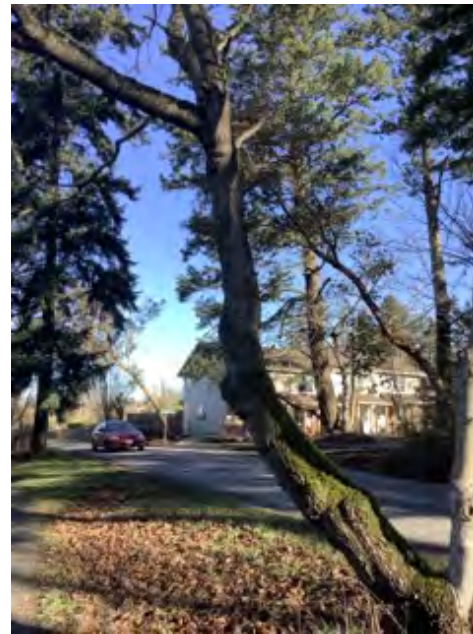
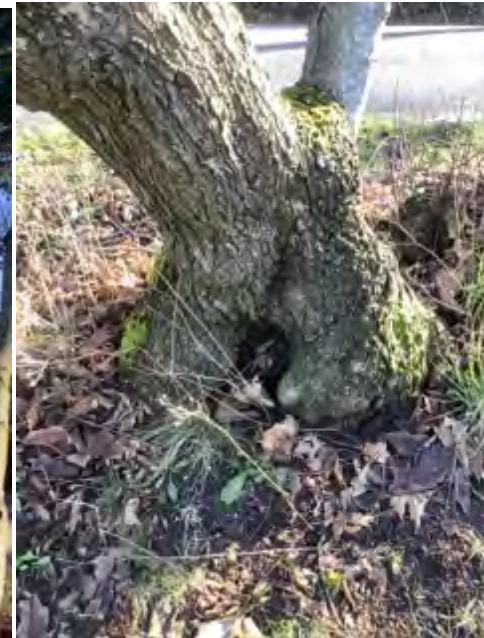
Tree	Species	DBH (in)	Drip Rad.	CRZ (ft)	Vigor	Structure	Risk	Pres Value	Recommendations
7	Maple <i>Acer species</i>	13.6	12.3	19.2	Fair	Fair	Moderate		Crown clean dead branches Remove large branch over path
Notes/ Defects	There is a cavity and Kretzschmaria at the base of the tree. Wound wood has formed a callous around the cavity. One sprouted stem looks healthy. There are a few dead branches over the path. One large stem of approximately 6-inch diameter that is over the path should be removed back to the main trunk. Dead branches in the crown should be cleaned out.

- #7 – Within 6 months prune out dead branches over the path and remove one mainly horizontal stem approximately 6 inches in diameter over the path by pruning back to the trunk. Re-assess in 5 years.

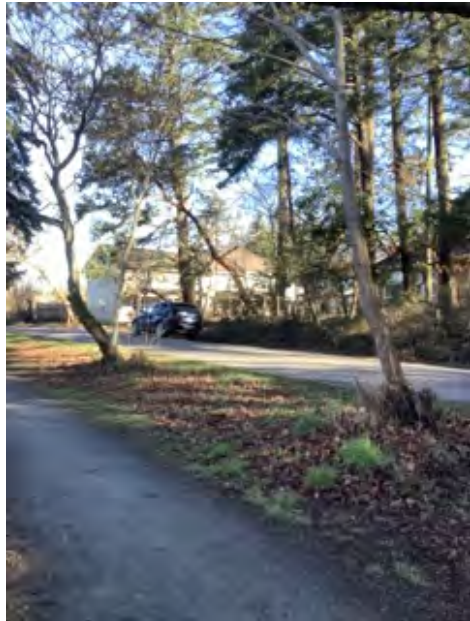
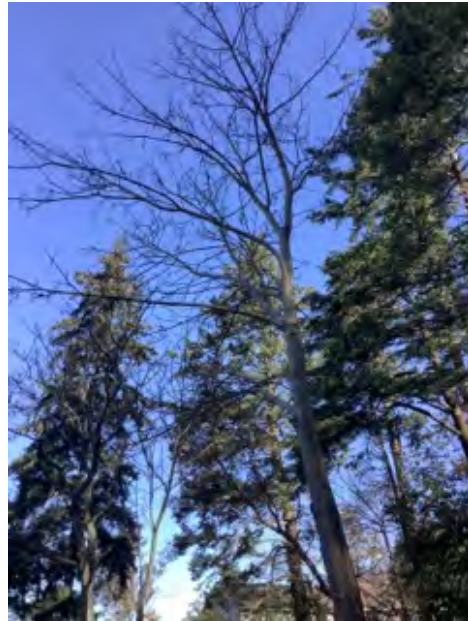
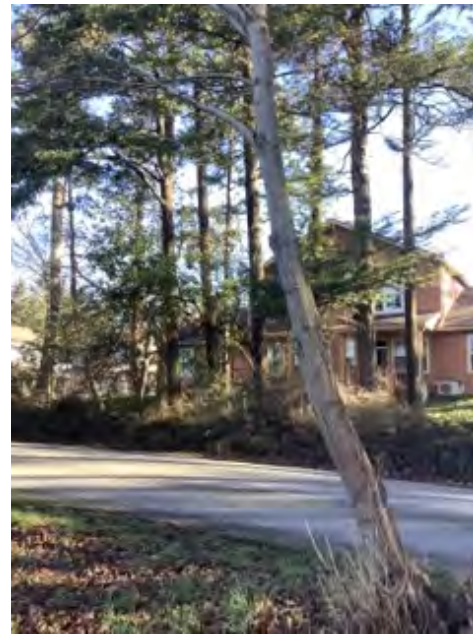
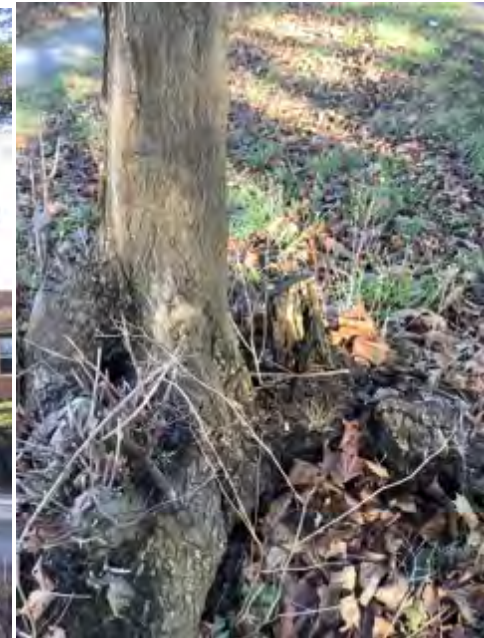
Tree	Species	DBH (in)	Drip Rad.	CRZ (ft)	Vigor	Structure	Risk	Pres Value	Recommendations
8	Maple <i>Acer species</i>	7.6	7.3	7.6	Good	Fair to Good	Low		Monitor for decay and vigor
Notes/ Defects	The stem is young and sprouted where the original trunk was removed down to a stump. There is Kretzschmaria on the stump that will likely infect the new stem. The tree has a slight lean and an asymmetrical crown weighted to the north. Failure is possible but the consequences would be minor. The tree should be monitored for spread of the fungus and viability of the new stem.

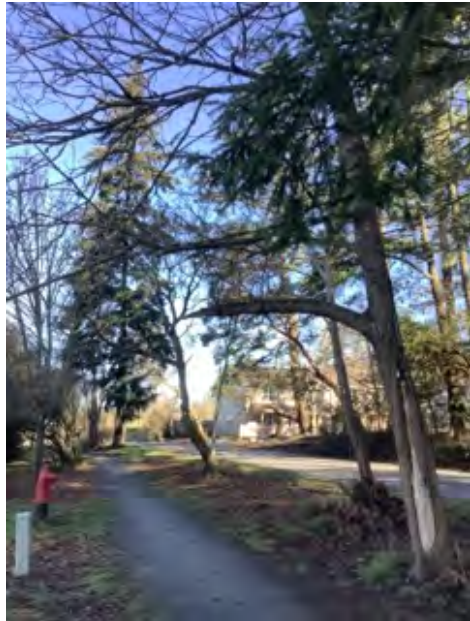
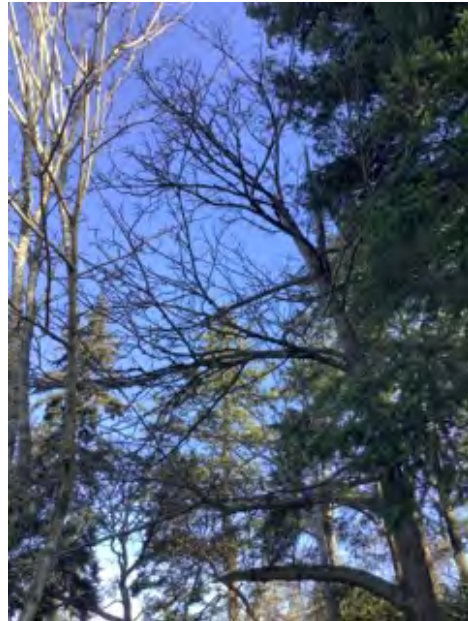
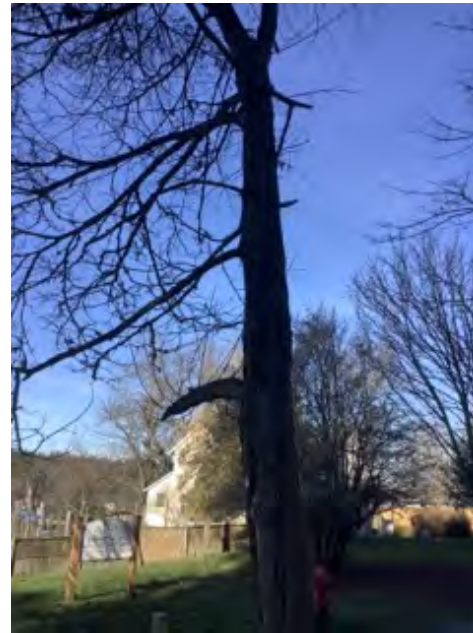
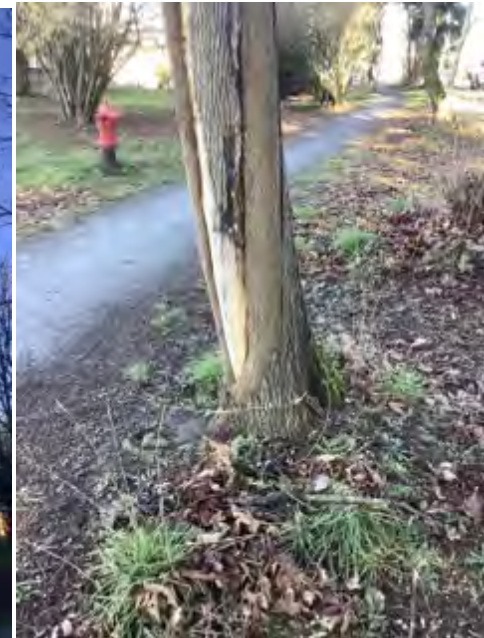
Tree	Species	DBH (in)	Drip Rad.	CRZ (ft)	Vigor	Structure	Risk	Pres Value	Recommendations
9	Maple <i>Acer species</i>	14.2	9.3	14.2	Poor to Fair	Poor	Moderate		Remove dead branches Reduce height; replace in future
Notes/ Defects	<p>The tree has a lean and asymmetrical crown weighted to the west over the path. There is a vertical column of decay up the entire length of the trunk on the side opposite the lean. The top is broken and there are some small diameter dead branches over the path. The tree is not viable and it should be removed and replaced within the next five years. Height reduction down to below the main union of two codominant stems is recommended in the short-term.</p>

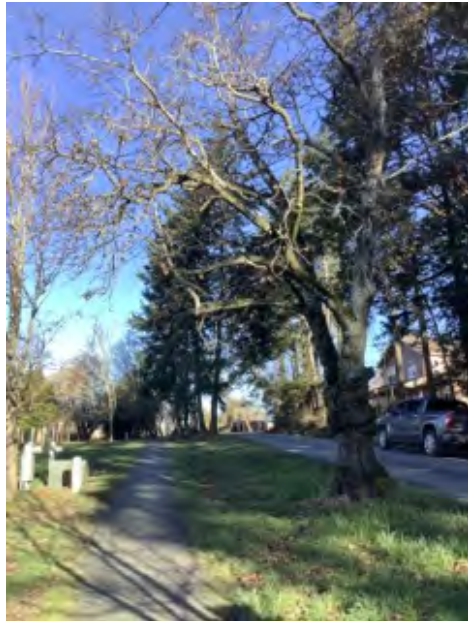
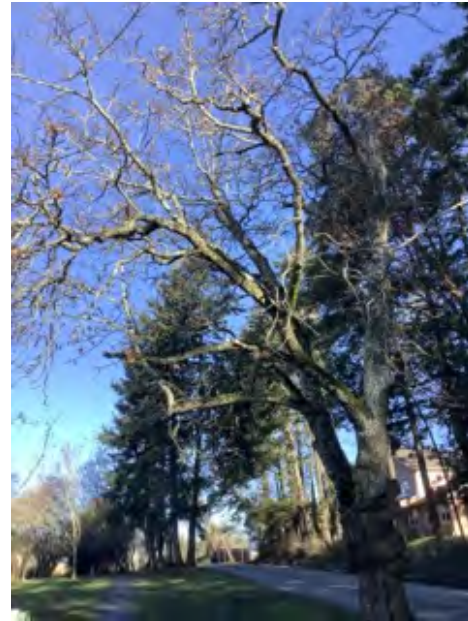
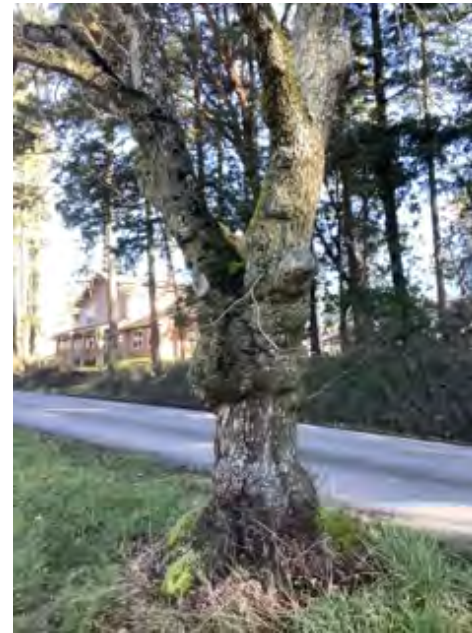
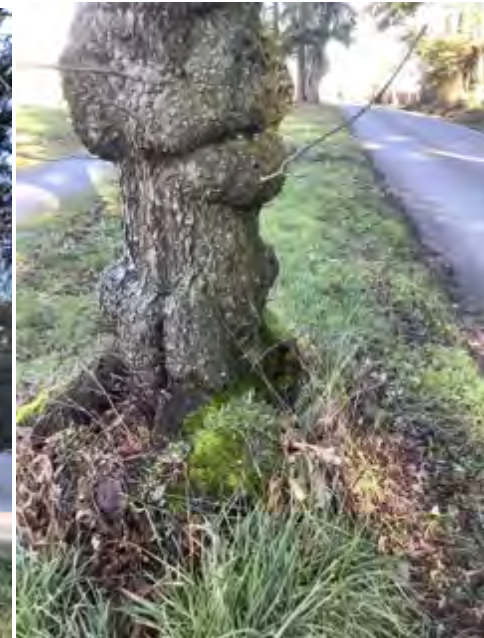
Tree	Species	DBH (in)	Drip Rad.	CRZ (ft)	Vigor	Structure	Risk	Pres Value	Recommendations
10	Maple <i>Acer species</i>	26.1	12.0	26.1	Fair to Good	Poor to Fair	Low		Retain tree
Notes/ Defects	The trunk has large burls and the top failed previously. All the branching unions look solid. There are a few small dead branches over the path that could be cleaned out of the crown. The tree is out of striking range of the nearby play area and it is a low risk. It can be retained at this time.

- #10 – Prune out dead branches from the crown within 6 months and retain the tree.

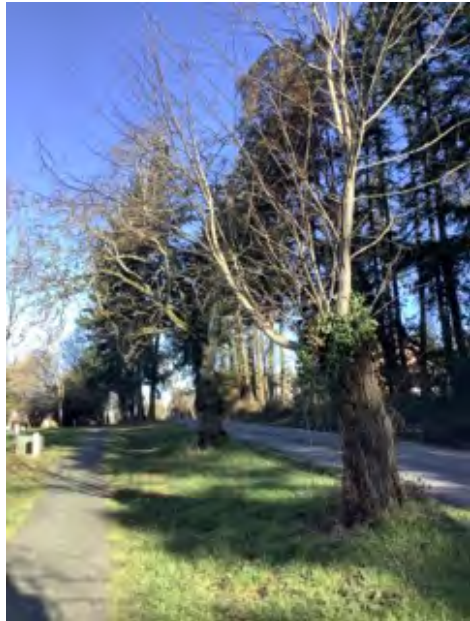
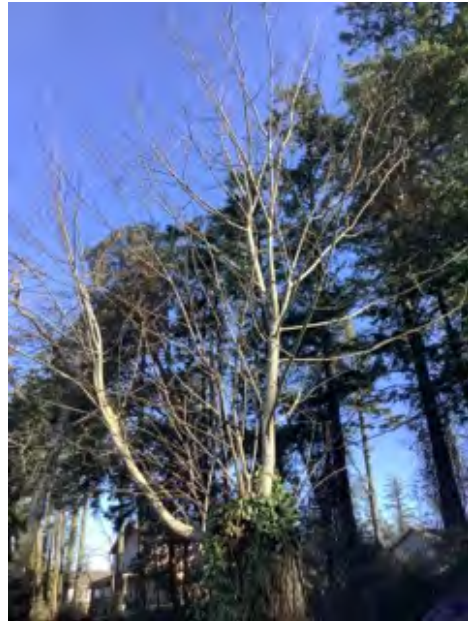
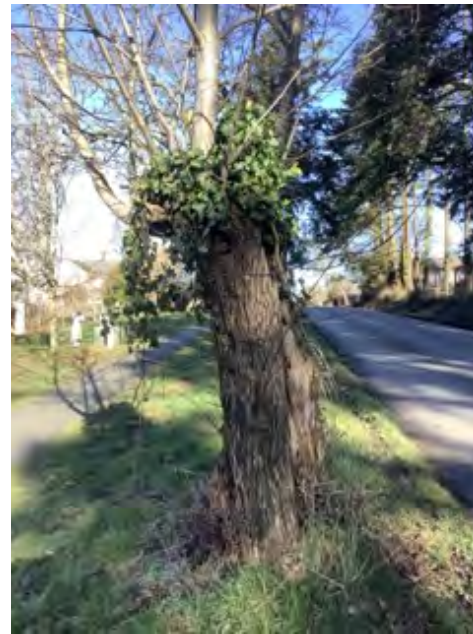
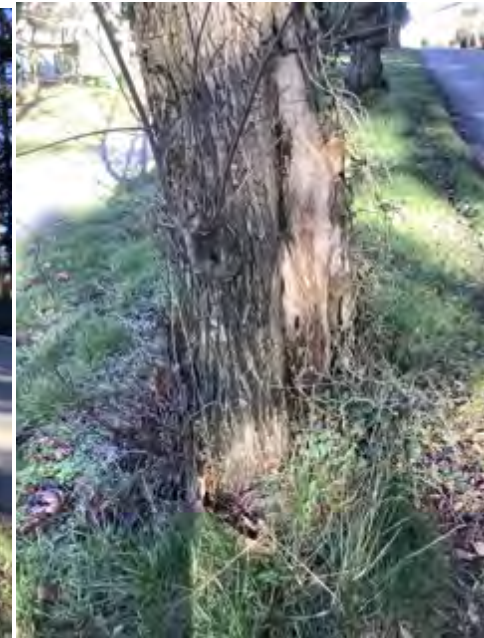
Tree	Species	DBH (in)	Drip Rad.	CRZ (ft)	Vigor	Structure	Risk	Pres Value	Recommendations
11	Maple <i>Acer species</i>	19.0	8.8	19.0	Good	Poor to Fair	Low		Remove English ivy Monitor stems for vigor
Notes/ Defects	This tree is comprised of several young sprouts growing out of a 7-foot tall stump. The stem attachments look solid. English ivy is colonizing the tree and should be controlled. The tree can be retained as a low risk and monitored for changes in the vigor of the stems.

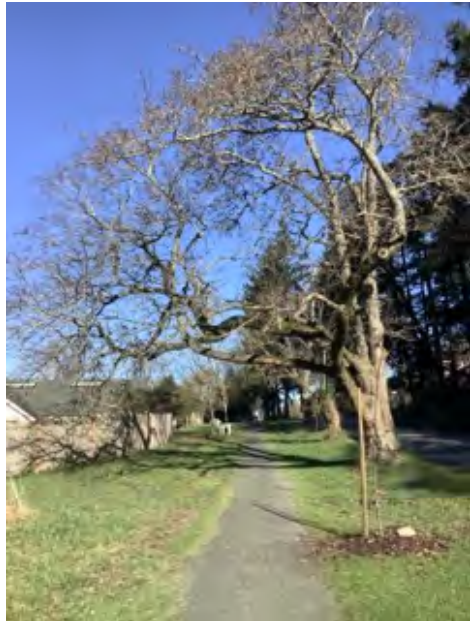
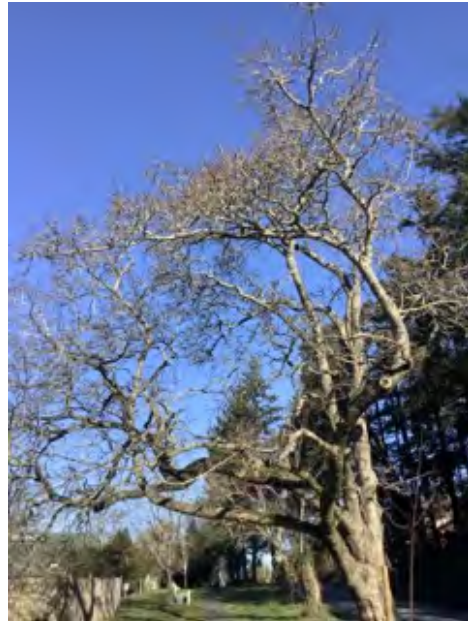
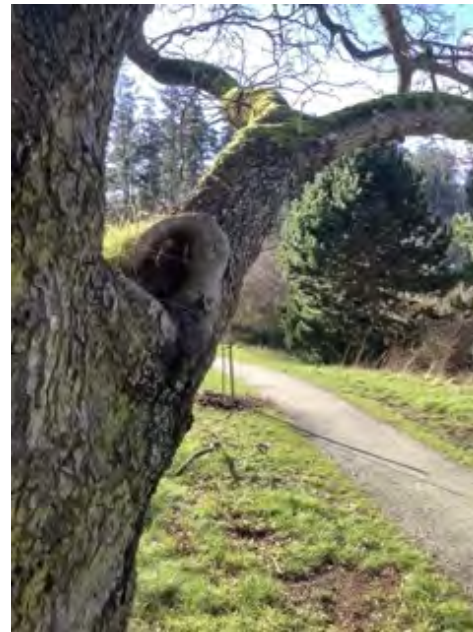
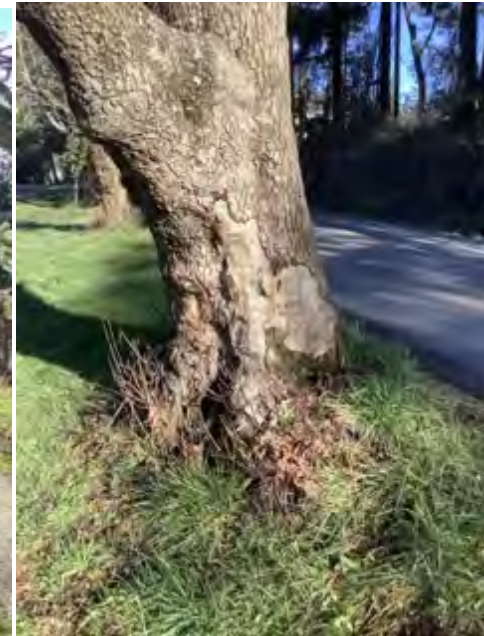
Tree	Species	DBH (in)	Drip Rad.	CRZ (ft)	Vigor	Structure	Risk	Pres Value	Recommendations
12	Maple <i>Acer species</i>	26.3	22.8	26.3	Good	Fair to Good	Low		End weight reduction Crown clean dead twigs
Notes/ Defects	<p>A patch of bark is gone on the lower south side of the trunk, possibly a result of vehicle strikes. There is a cavity in the large stem growing to the south over the path, but there is abundant supporting response wood below the wound. There is some minor twig dieback in the crown. The tree is very healthy, overall. The nearby school outdoor play area is out of striking range. End weight reduction of 5 to 6 feet on the branches nearest the play area will reduce the likelihood of branch failure and assist tree preservation.</p>

- #11 – Remove the English ivy and monitor for weak branch attachments at 5-year intervals.
- #12 – Within 12 months remove one large low branch over the path back to the primary union that is on the south side of the trunk and on the stem with a cavity. Retain the stem to avoid a large wound on the trunk. Reduce the length of the branches on the west side of the tree near the play area by 5 to 6 feet for endweight reduction.
- Consider planting new trees interspersed with the existing trees for a phased canopy replacement. Consult with a local nursery or Conservation District about appropriate tree species selection, planting standards, and maintenance.
