# *Investigation Report*

## *CenturyTel of Inter Island d/b/a CenturyLink*

*UT-132234*

*Staff Investigation  
Consumer Protection  
Regulatory Services*

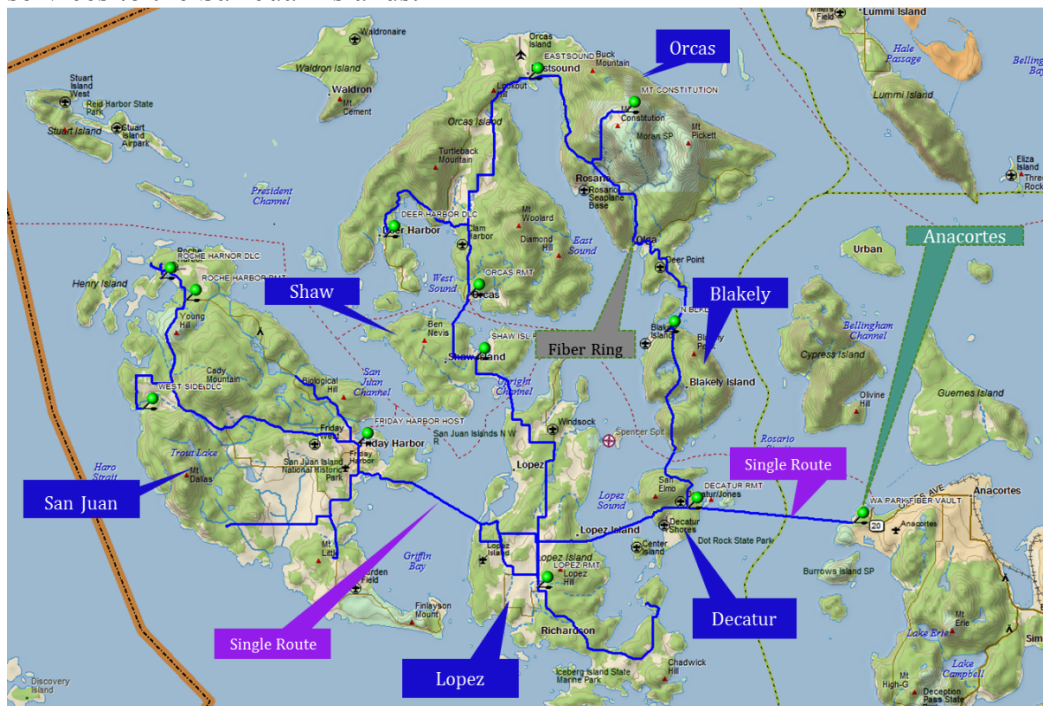
Long distance calling and E911 services require a connection between the central office host switch in Friday Harbor (located on San Juan Island) and the remote line switches located on the other islands. The two fuchsia flags identified as “single route” on the chart above represent the two connections that, if severed, would isolate the central office host switch in Friday Harbor.

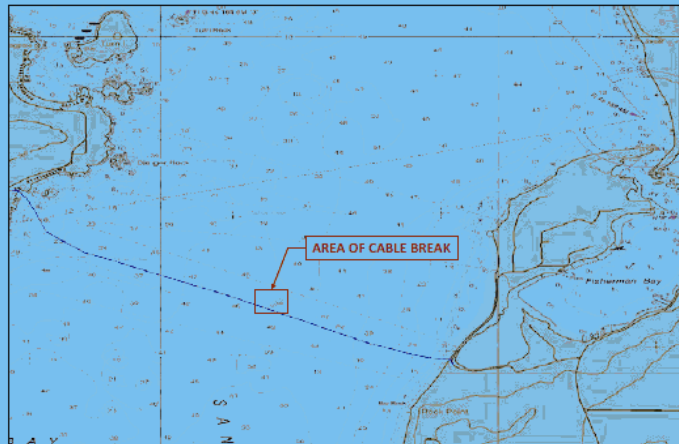
The following is my expert report, including assessments and recommendations, related to the Century Link cable break between Lopez Island and San Juan Island. The cable break was observed to have occurred sometime between the hours of 3:00 am and 4:00 am on November 5, 2015 midway in the San Juan Channel in about 230 feet of water. The Century Link submarine cable was installed in 1999 and was laid within a designated Cable Corridor. The cause of the break is still unknown.

Figure 1 - Area of Cable Break

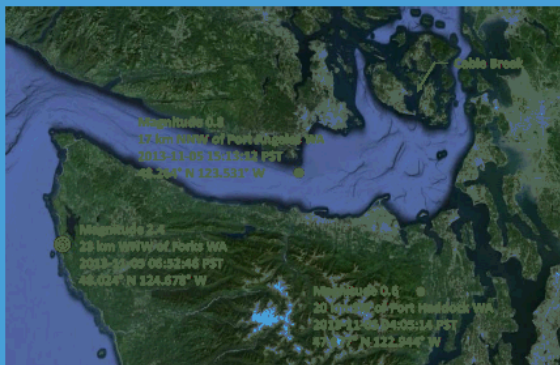
Figure 24 - USGS Historical Data November 5, 2013

Given the magnitude of the earthquakes, the 2013 OPALCO route survey and video observations of the rock features in the vicinity of the break, it seems very unlikely that any of these earthquakes were responsible for the cable break. The OPALCO survey and the ROV video inspection show no indication of instability of the rocky area. There are no signs of slumping or rock slides in the area of the break.

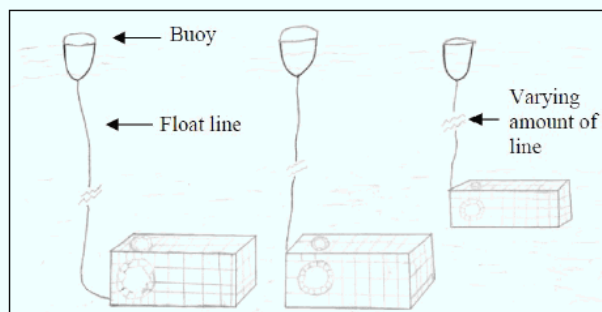
Crab pot fishing depths in the area are usually shallower than 100', although 200' is not unheard of. The breaking strength of a crab pot buoy line is much lower than that of an armored fiber optic cable of this diameter. Buoys are usually attached with synthetic line about ½" diameter, with a maximum breaking strength on the order of 3,700 – 7,000 lb. Even if doubled it may not reach the breaking load of an armored cable such as this. That said, it is possible for multiple strands to tangle a cable. If a tangled pot and line were dragged across the seabed by a snagged piece of towed gear, it could cause significant damage.

Figure 26- Crab Pots with One Pot per Buoy Line

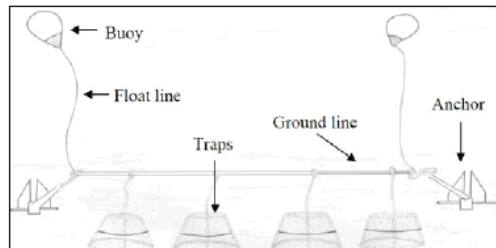
Shrimp pots are fished by fewer than 20 State licensed vessels in Puget Sound, as well as an undetermined number of Treaty fishermen. The pots are similar in size to crab pots but they may be fished on “ground lines”, with many pots tied along a line on the seabed, and a buoy at each end of the line. This means that if the buoys are lost, fishermen are more likely to try to recover them with grapnels. In other regions this has caused cable faults. Fishing depths are typically 200’ to 400’, encompassing the fault range. However, the pots shown in the ROV video are clearly crab pots, not shrimp pots. Moreover, shrimp pot fishing at night is prohibited.

Figure 27 -- Shrimp Pots on a Common Ground Line

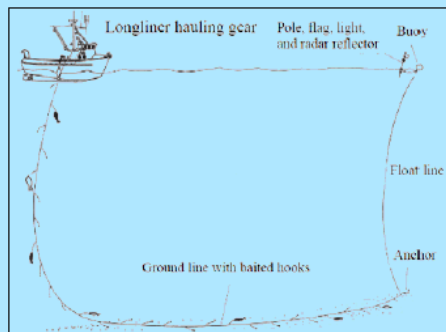
Bottom longlines are used for halibut in Puget Sound. A long ground line or main line has a series of branch lines attached, with a baited hook on the end of each branch line. Their breaking strength is generally well below that of a FO cable. However in rare cases they have caused cable faults in other regions, either by tangles, grapnel recovery, or hook point penetration of cable insulation.

Figure 28 - Bottom Longline

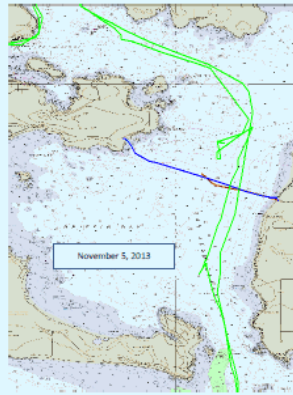
AIS data initially pointed to activity of a research vessel. The RV Centennial is capable of such a complete cable break, with 58' length, 425 HP engine, winches, trawl and dredge equipment for scientific sampling. However AIS records indicated that the RV Centennial was at the dock in Friday Harbor when the fault was reported. It did not arrive in the break area until approximately 10:14 PM PST on transit to an area well south of the break. It returned to the break area and conducted more complex maneuvers at slow speed at approximately 1:30 PM PST, almost ten hours after the reported alarm.

Figure 29 - RV Centennial Nov 5 2013

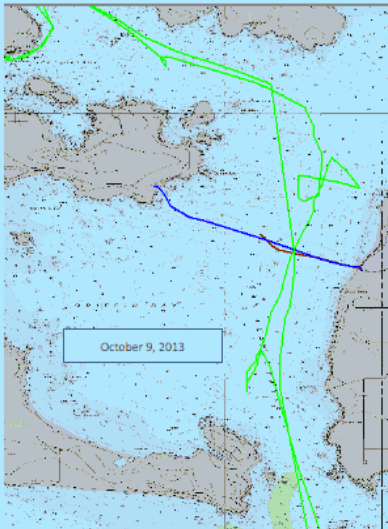
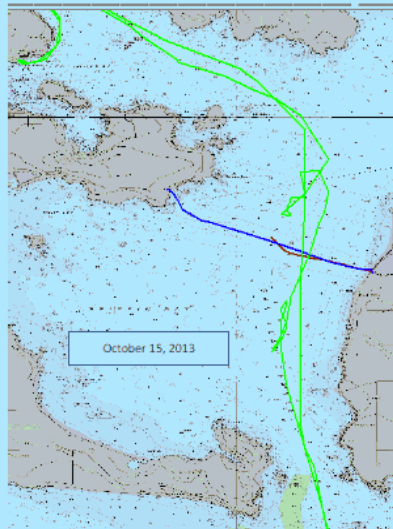
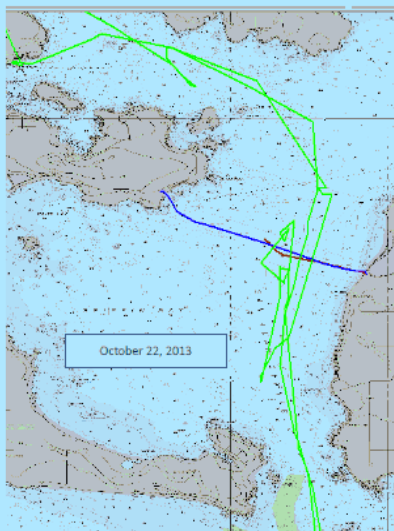
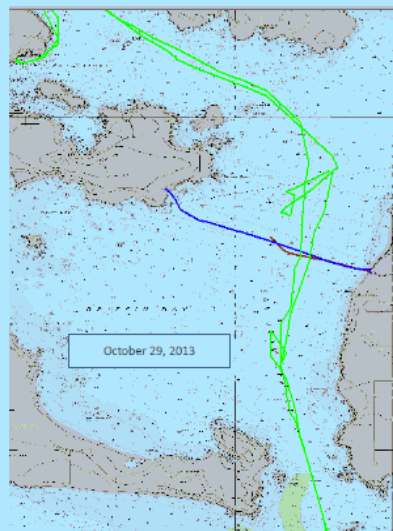
The RV Centennial calendar (available in the Friday Harbor Laboratory's website) indicated that the RV Centennial made similar cruises on October 9, October 15, October 22 and October 29 of 2013. Historical vessel tracks to the RV Centennial for those dates all show changes in speed and heading in the vicinity of the cable areas.

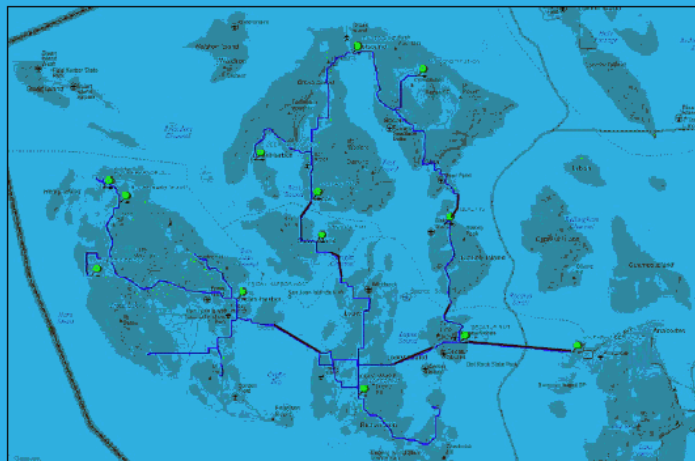
Figure 37 - Century Link Submarine Cables in the San Juan Islands

NOAA nautical charts clearly show the cable areas associated with all of the Century Link cables in the San Juan Islands. Most of the cable crossings are in relatively shallow water and the threats from anchors and bottom fishing are low. The cable from Anacortes to Decatur Island crosses the Rosario Strait, which is a major shipping channel. More than 500 oil tankers pass through the strait each year, to and from the Cherry Point Refinery and refineries near Anacortes. The strait is in constant use by vessels bound for Cherry Point, Bellingham, Anacortes, and the San Juan Islands. There is a low risk of a large vessel dropping anchor, unintentionally or in an emergency situation. Should an anchor ever cause a break in the cable, a repair operation would be extremely difficult as the repair vessel would have to work in the middle of the shipping lanes. The company should contact Port Authorities to inquire about restrictions to performing repair operations in the Rosario Strait. Any such restriction would require special repair operations, possibly abandoning the cable in the shipping lanes and installing a new section of cable.

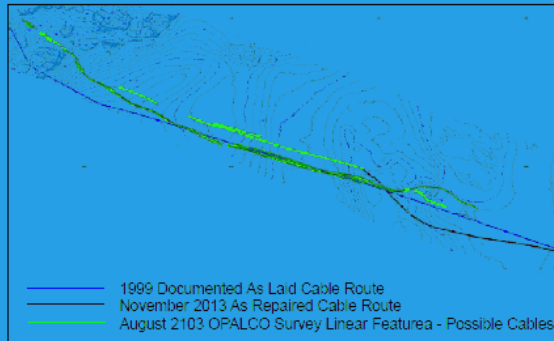
From conversations with UTC and Century Link, there are several live cables and several out of service cables laid in the same vicinity as the Century Link cable. From the ROV video inspection and the 2013 OPALCO survey, it is clear that these cables cross each other.

Figure 38 - Other Cables in the San Juan Channel

Great care will need to be taken on future cable repairs so as not to damage another live cable. As additional cable are planned for the future, Century Link and other cable owners should interface with each other to establish new non-conflicting cable routes. Removal of out of service cables is now required at many landing sites around the world. Consideration for cable removal at landing sites may also be required at some into to make room for new cables.
